March 14, 2013

Re: Papa Johns
ADA Compliance Evaluation

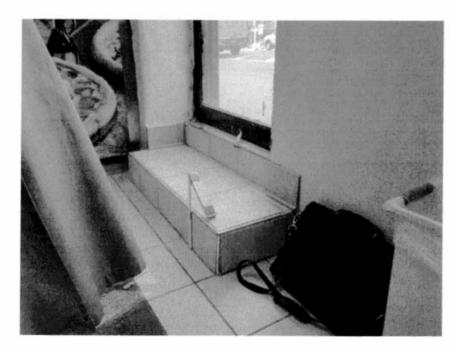
In order to enter the space through the entrance along the sidewalk of 2 Av., a person must descend two (2) steps of unequal riser height (6" and 7") and unequal tread depth.

Picture 1: Store entrance, 6" and 7" stairs on entrance.

- 1. Entrance steps and doorway: To address this condition, a permanent small ramp can be constructed from the sidewalk level up to the main floor level; the ramp would require appropriate slope, railings, and signage as required by 28 C.F.R. 36 to provide an accessible and properly designated entrance. In the alternative, a wheelchair lift may be used. In the alternative, an ADA compliant portable ramp with a non-slip surface may be used in conjunction with ADA accessible signage and buzzer to comply with 28 C.F.R. Part § 36.304 (e). A cost estimate of providing an ADA compliant wheelchair lift is approximately \$10,000.

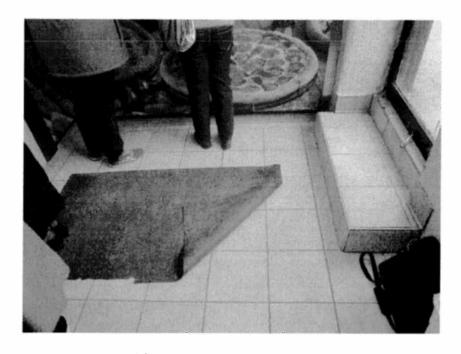
Picture 2: Unsecured entry mat

- 5. Secured Mats: The existing non ADA compliant mats in the store layout can be secured to be in compliance with 28 C.F.R. Part 36 and 2010 Standard, Section 302.2.

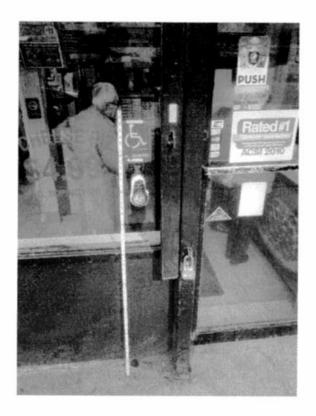
Picture 3: Inaccessible ADA signage and buzzer

- 4. Signage: Appropriate visual and/or tactile signage regarding services available should be provided to comply with 28 C.F.R. Part 36, Section 4.1.3(16) and 28 C.F.R. Part 36, Section 4.30.4. A cost estimate of providing appropriate signage is approximately \$200.

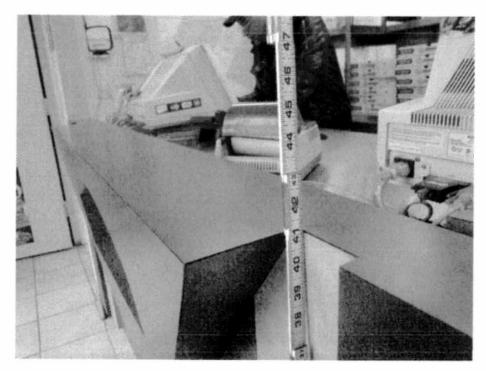
Picture 4: Inaccessible service and transaction counter 41" (h)

- 2. Transaction counter: The existing non ADA compliant transaction counter can be modified to comply with 28 C.F.R. Part 36, Section 7.2(1), which requires that a portion of the main counter (measuring a minimum of 36 inches in length) be provided, with a maximum height of 36 inches above the finished floor. The cash register display screens should be lowered with the transaction counter. A cost estimate of lowering the transaction counter is \$2.000.

- 3. Service Counter: The existing non ADA compliant service counter can be modified to comply with 2010 ADAAG, Section 902.3 which requires a portion of the main counter (measuring a minimum of 36" in length) be provided with a maximum height of 36" above the finished floor. The cost estimate of lowering the service counter is the same as the cost for lowering the transaction counter.
